**INSTITUTE FOR RESEARCH AND
CERTIFICATION**

REPORT

from test no. LL/105/2018/A

Subject: WATEX lighting fixtures test

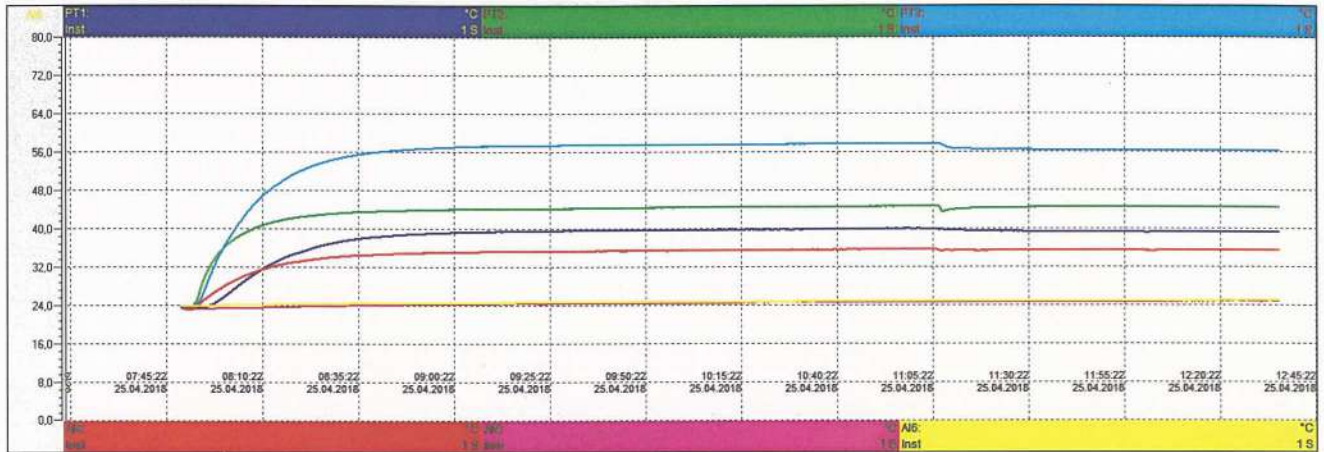
Fig. 1. Heating characteristics.

The temperature was recorded using the sensors installed in the locations specified in Table 1. Temperature curves during heating in individual locations are presented on the recorded diagrams (Fig. 1).

The temperature values recorded with a video recorder were used for determining ambient temperature and determining the time, when the temperature of the tested object was stabilized. After the heating process ended, pictures were taken with a thermographic camera in order to determine the spots with the highest temperature. Figure 2÷3 presents the selected pictures from a thermographic camera.

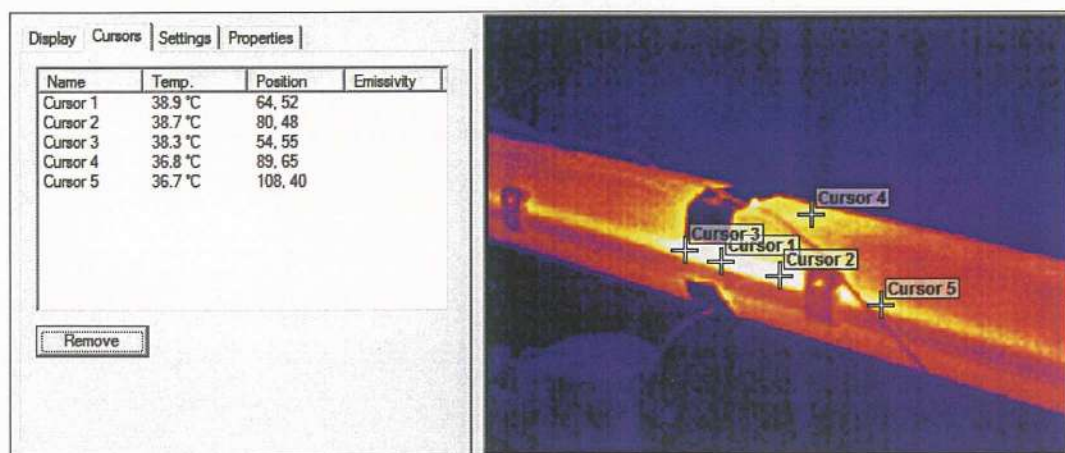
Fig. 2. Thermographic photo – housing (shed).

The highest temperature of **the external surface** recorded with a thermographic camera was $(38.9 \pm 3.7)^\circ\text{C}$. At that moment, the ambient temperature was $(25.2 \pm 0.8)^\circ\text{C}$.

Maximum temperature recalculated for ambient temperature of 40°C was $(53.7 \pm 4.5)^\circ\text{C}$.

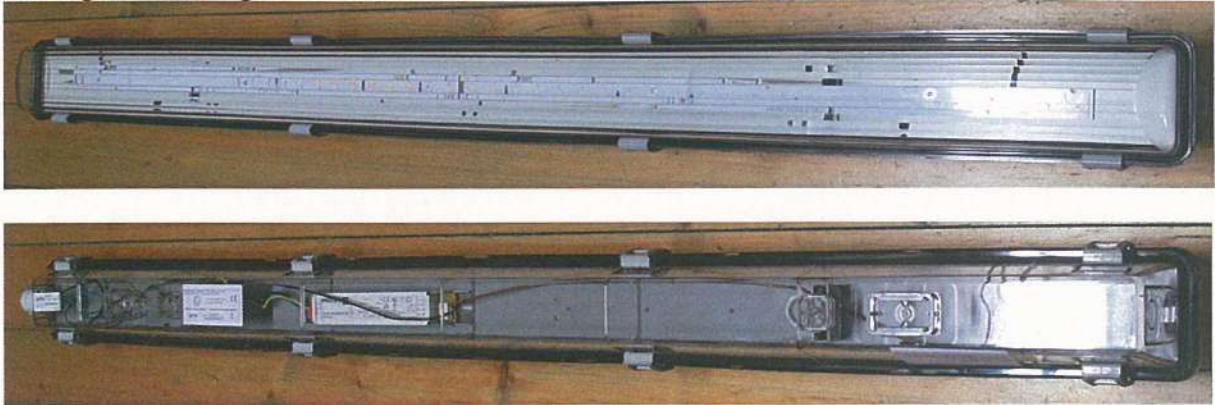
Fig. 1. Tested lighting fixtures.

Notable damages of the coating on metal elements constituting the supporting construction for the electrical equipment inside two fixtures

with white sealing were found. Furthermore, a cable gland in one of the fixtures with white sealing was damaged.

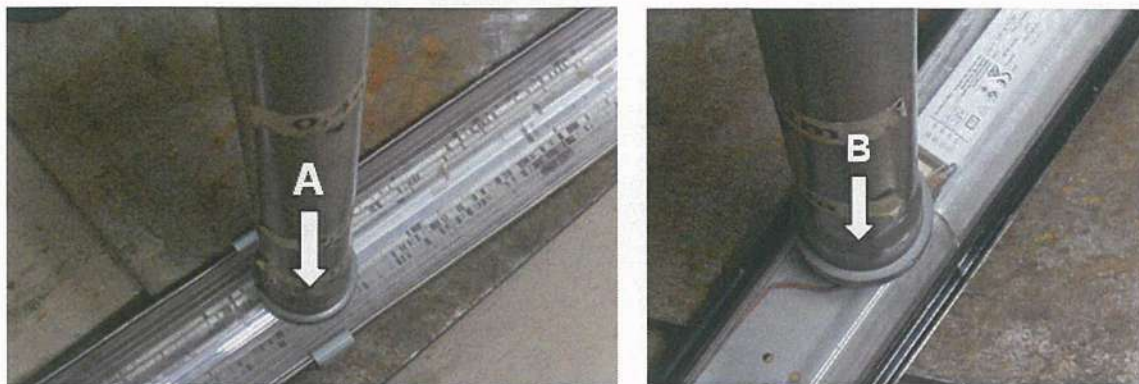
Fig. 4. Spot of swingle impact in the fixture enclosure.

The device was subject to impact test consisting of impact of a 1 kg swingle dropping onto the enclosure from 0.7 m.

The location of the impact is shown on fig. 4. Test results are presented in table 2.

The tests did not result in loss of functionality of the device.

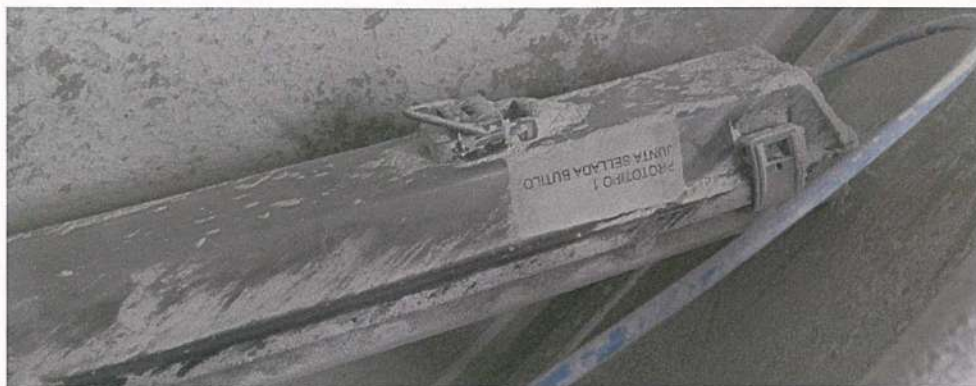
Fig. 5. Enclosure of WATEX fixture after a dust chamber test.

The enclosure test was performed in a dust chamber with vacuum. Vacuum pressure was 2 kPa. Vacuum speed was less than 20-times the enclosure volume per hour. Test time was 8 hours.

After completion of test, the sample was subject to visual inspection. No traces of dust inside the enclosure were stated.

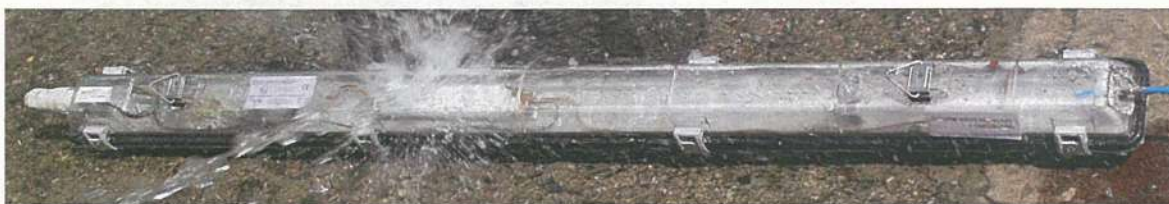
Fig. 6. Enclosure of WATEX fixture after a water test.

The enclosure test was performed with an outlet nozzle for IPX6 measurement. Water flow was 100l/minute. Test time was 3 minutes.

After completion of the test, the enclosure was subject to visual inspection. No traces of water were found inside.

The enclosures of WATEX lighting fixtures meet the requirements of IP66 protection class.
