REPORT

from test no. LL/105/2018/A

Subject: WATEX lighting fixtures test

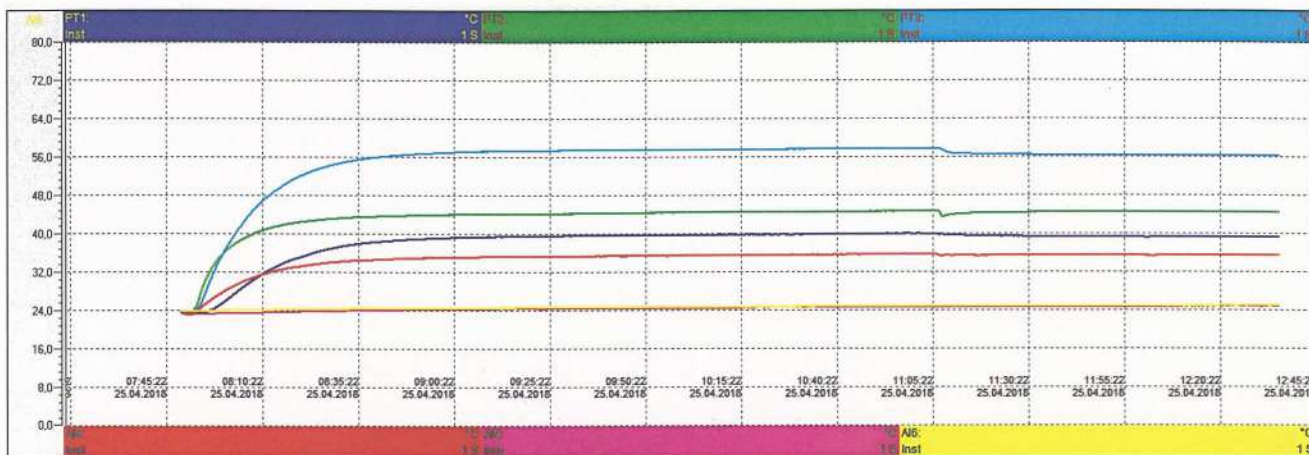
The temperature was recorded using the sensors installed in the locations specified in Table 1. Temperature curves during heating in individual locations are presented on the recorded diagrams (Fig. 1).

Fig. 1. Heating characteristics.

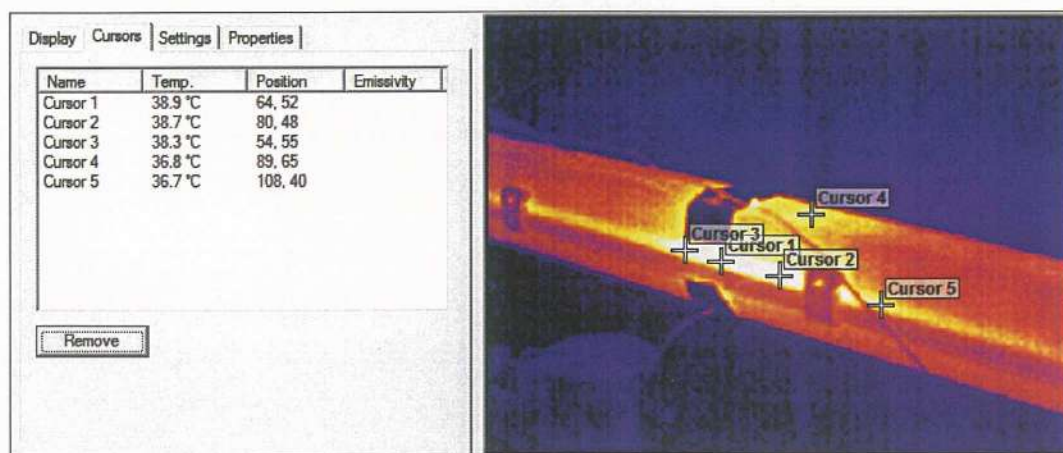
Fig. 2. Thermographic photo – housing (shed).

The highest temperature of **the external surface** recorded with a thermographic camera was $(38.9 \pm 3.7)^\circ\text{C}$. At that moment, the ambient temperature was $(25.2 \pm 0.8)^\circ\text{C}$.

Maximum temperature recalculated for ambient temperature of 40°C was $(53.7 \pm 4.5)^\circ\text{C}$.

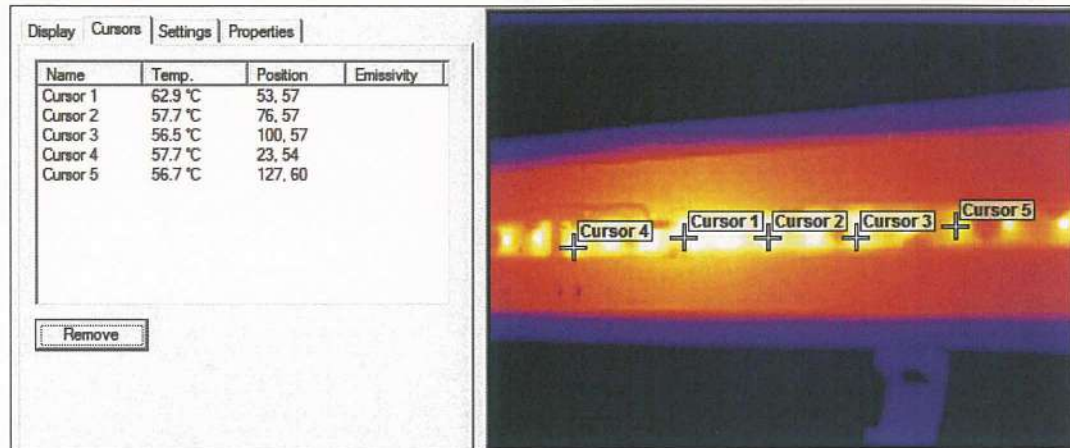
Fig. 3. Thermographic photo – interior (LED light strip).

The highest temperature of **the device** recorded with a thermographic camera was $(62.9 \pm 6.0)^\circ\text{C}$. At that moment, the ambient temperature was $(25.2 \pm 0.8)^\circ\text{C}$.

Maximum temperature recalculated for ambient temperature of 40°C was $(77.7 \pm 6.8)^\circ\text{C}$.

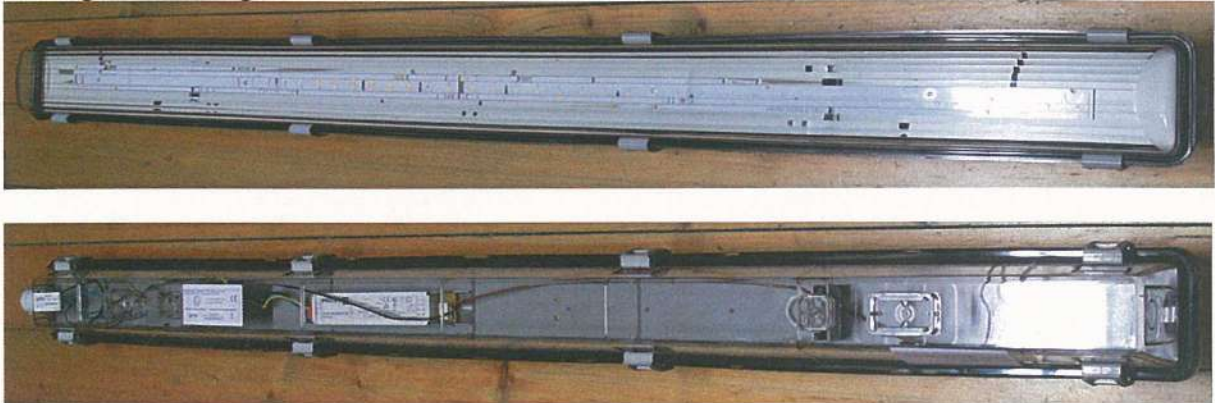
Notable damages of the coating on metal elements constituting the supporting construction for the electrical equipment inside two fixtures

with white sealing were found. Furthermore, a cable gland in one of the fixtures with white sealing was damaged.

Fig. 1. Tested lighting fixtures.

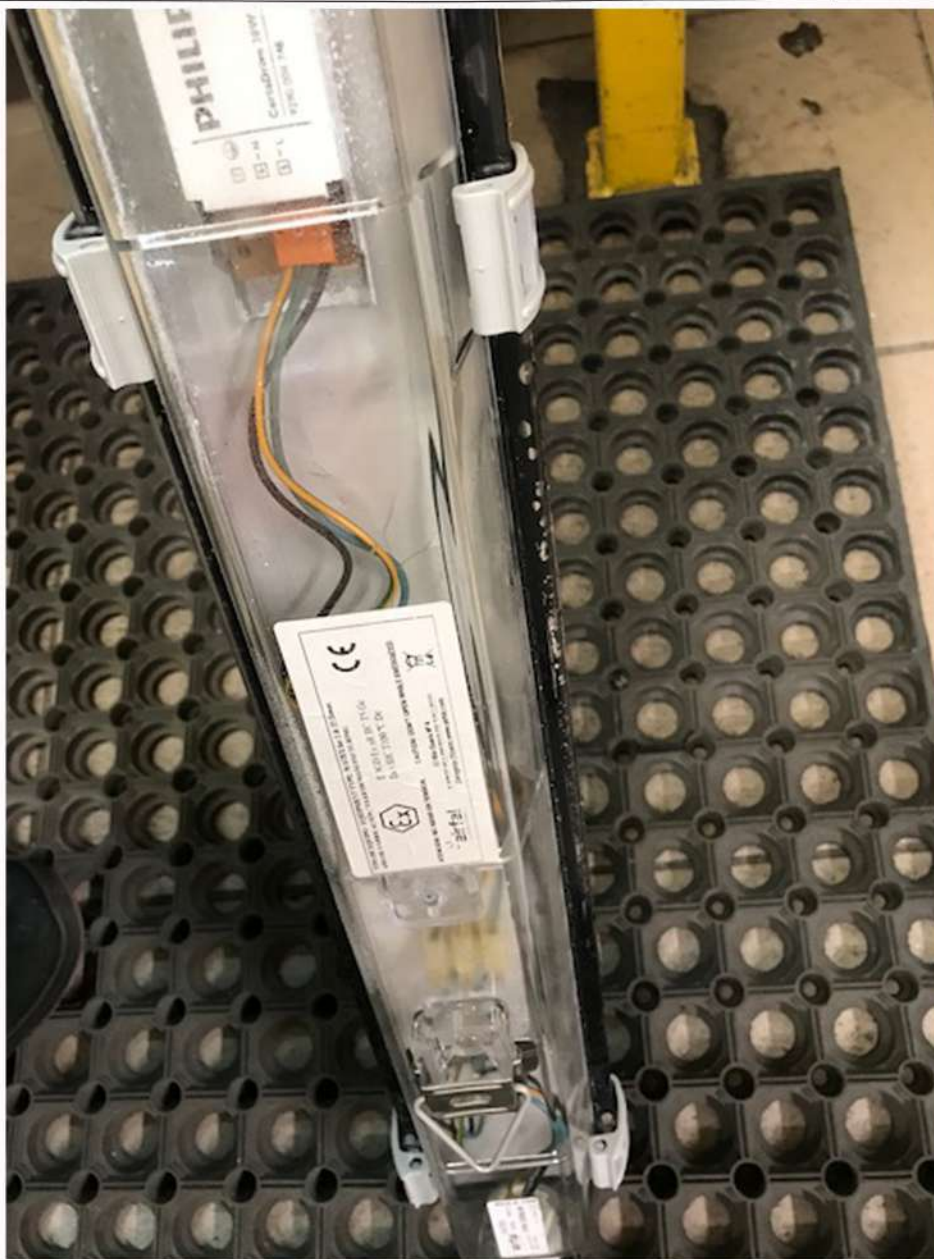
Fig. 3. Interior of the fixture after the climate tests.

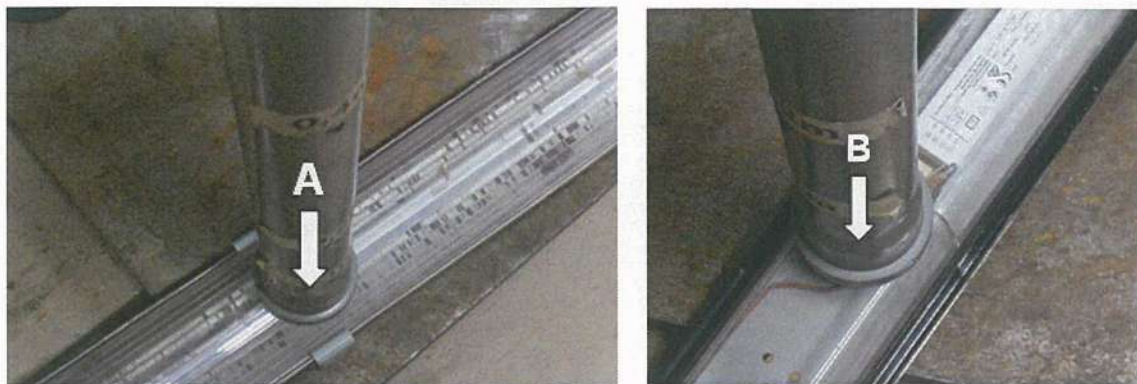
The device was subject to impact test consisting of impact of a 1 kg swingle dropping onto the enclosure from 0.7 m.

The location of the impact is shown on fig. 4. Test results are presented in table 2.

Fig. 4. Spot of swingle impact in the fixture enclosure.

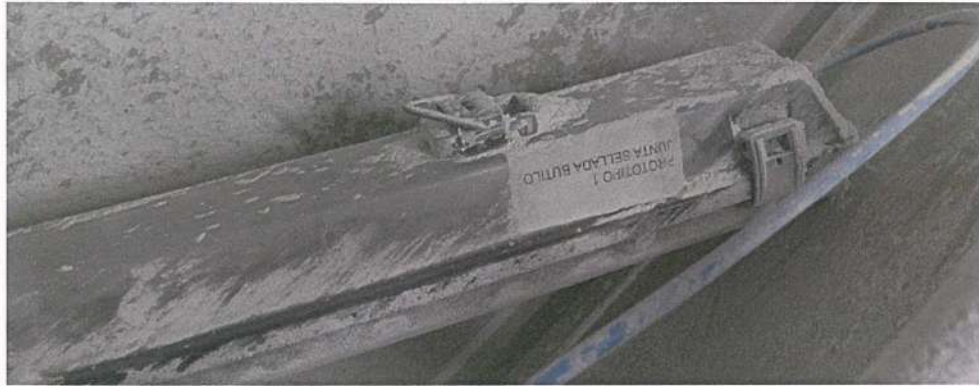
The enclosure test was performed in a dust chamber with vacuum. Vacuum pressure was 2 kPa. Vacuum speed was less than 20-times the enclosure volume per hour. Test time was 8 hours.

After completion of test, the sample was subject to visual inspection. No traces of dust inside the enclosure were stated.

Fig. 5. Enclosure of WATEX fixture after a dust chamber test.

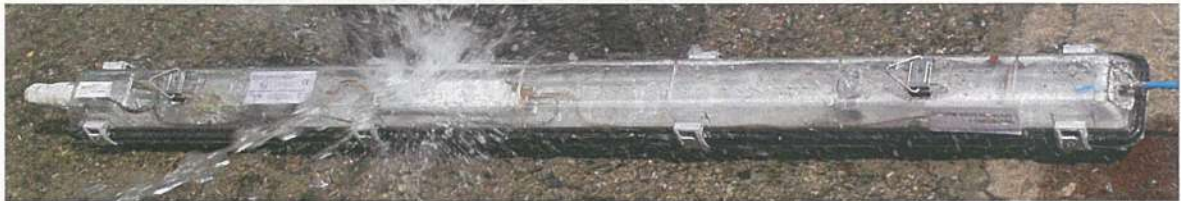
The enclosure test was performed with an outlet nozzle for IPX6 measurement. Water flow was 100l/minute. Test time was 3 minutes.

After completion of the test, the enclosure was subject to visual inspection. No traces of water were found inside.

Fig. 6. Enclosure of WATEX fixture after a water test.
